School Assessment Report

District: Limon RE-4J
School: Limon K-12
Date: Apr 01, 2011

School Name: Limon K-12

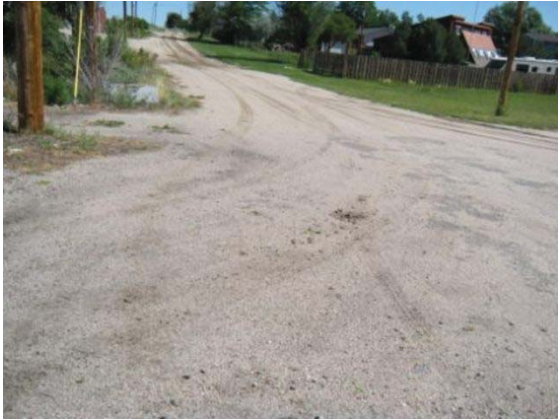
System: G2010 - Roadways

Analysis: The system age is either beyond expected life or does not meet its intended performance under the Guidelines. The system may be in service and functioning but it is recommended to be replaced due to probable increased condition budget needs, the potential failure of its components, or in order to meet the performance Guidelines for this system. The system was installed in 1923. It has a 50-year service life which expired in 1973.

Qty: 1-Ea.

Condition Budget: \$269,596

Recommendation: The system should be replaced.

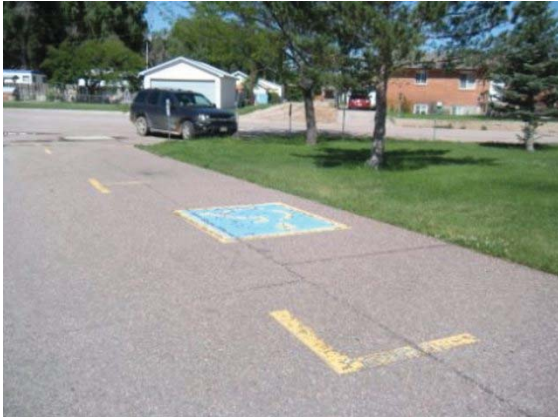
System: G2020 - Parking Lots

Analysis: The system age is either beyond expected life or does not meet its intended performance under the Guidelines. The system may be in service and functioning but it is recommended to be replaced due to probable increased condition budget needs, the potential failure of its components, or in order to meet the performance Guidelines for this system. The system was installed in 1923. It has a 50-year service life which expired in 1973.

Condition Budget: \$489,996

Recommendation: The system should be replaced.

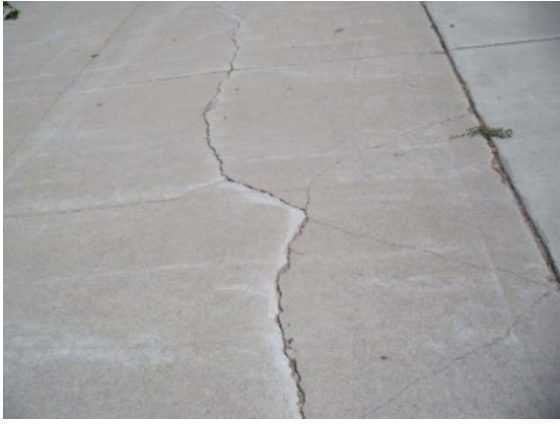
System: G2030 - Pedestrian Paving

Analysis: The system age is either beyond expected life or does not meet its intended performance under the Guidelines. The system may be in service and functioning but it is recommended to be replaced due to probable increased condition budget needs, the potential failure of its components, or in order to meet the performance Guidelines for this system. The system was installed in 1923. It has a 50-year service life which expired in 1973.

Location: Site
Distress: Beyond Expected Life
Category: Deferred Maintenance
Priority: 3 - Necessary- 2-5 Yrs
Correction: Renew System
Qty: 1-Ea.
Condition Budget: \$129,879

Recommendation: The system should be replaced.

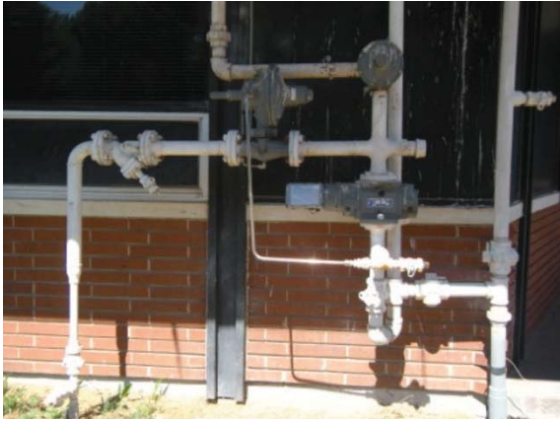
System: G2040 - Site Development

Analysis: The system is missing.

Location: Site
Material: Site Development
Distress: Missing
Category: Compliance
Priority: 3 - Necessary- 2-5 Yrs
Notes: The natural gas meter is not fenced.
Correction: Replace and/or add fencing for security/appearance
Qty: 1-Ea.
Condition Budget: \$6,006

Recommendation: The system should be installed.

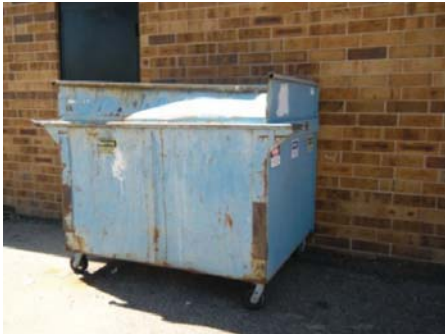
Location: Site
Material: Site Development
Distress: Missing
Category: Environmental
Priority: 3 - Necessary- 2-5 Yrs
Notes: The trash area is not enclosed.
Correction: Replace and/or add fencing for security/appearance
Qty: 1-Ea.
Condition Budget: \$5,276

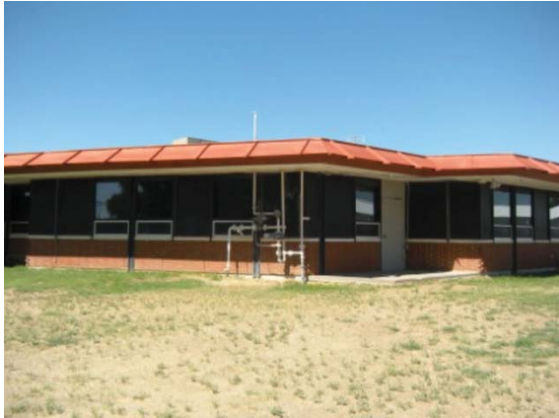
System: G2050 - Landscaping

Analysis: The system age is either beyond expected life or does not meet its intended performance under the Guidelines. The system may be in service and functioning but it is recommended to be replaced due to probable increased condition budget needs, the potential failure of its components, or in order to meet the performance Guidelines for this system. The system was installed in 1923. It has a 10-year service life which expired in 1933.

Location: Site
Distress: Beyond Expected Life
Category: Deferred Maintenance
Priority: 3 - Necessary- 2-5 Yrs
Correction: Renew System
Qty: 1-Ea.
Condition Budget: \$462,446

Recommendation: The system should be replaced.

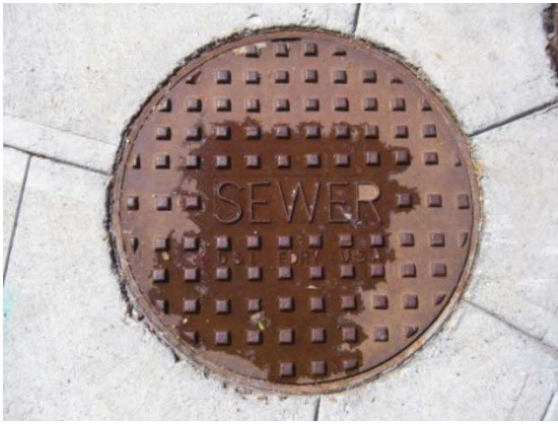
System: G3020 - Sanitary Sewer

Analysis: The system age is either beyond expected life or does not meet its intended performance under the Guidelines. The system may be in service and functioning but it is recommended to be replaced due to probable increased condition budget needs, the potential failure of its components, or in order to meet the performance Guidelines for this system. The system was installed in 1923. It has a 50-year service life which expired in 1973.

Location: Site
Distress: Beyond Expected Life
Category: Deferred Maintenance
Priority: 3 - Necessary- 2-5 Yrs
Correction: Renew System
Qty: 1-Ea.
Condition Budget: \$165,300

Recommendation: The system should be replaced.

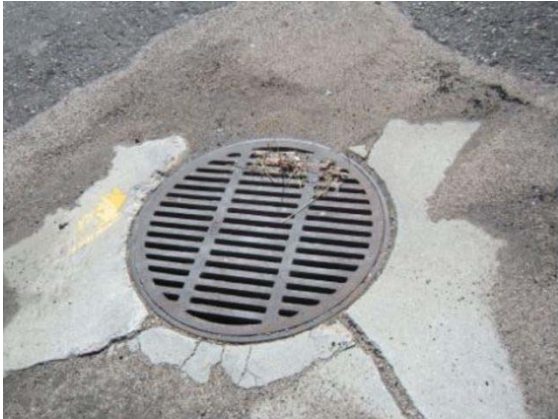
System: G3030 - Storm Sewer

Analysis: The system age is either beyond expected life or does not meet its intended performance under the Guidelines. The system may be in service and functioning but it is recommended to be replaced due to probable increased condition budget needs, the potential failure of its components, or in order to meet the performance Guidelines for this system. The system was installed in 1923. It has a 50-year service life which expired in 1973.

Location: Site
Distress: Beyond Expected Life
Category: Deferred Maintenance
Priority: 3 - Necessary- 2-5 Yrs
Correction: Renew System
Qty: 1-Ea.
Condition Budget: \$96,425

Recommendation: The system should be replaced.

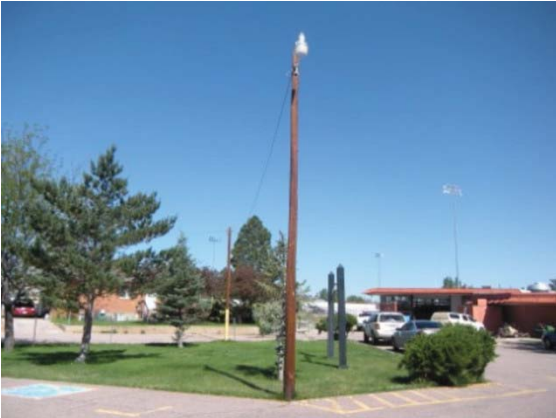
System: G4020 - Site Lighting

Analysis: The system age is either beyond expected life or does not meet its intended performance under the Guidelines. The system may be in service and functioning but it is recommended to be replaced due to probable increased condition budget needs, the potential failure of its components, or in order to meet the performance Guidelines for this system. The system was installed in 1923. It has a 30-year service life which expired in 1953.

Location: Site
Distress: Beyond Expected Life
Category: Deferred Maintenance
Priority: 3 - Necessary- 2-5 Yrs
Correction: Renew System
Qty: 1-Ea.
Condition Budget: \$226,303

Recommendation: The system should be replaced.

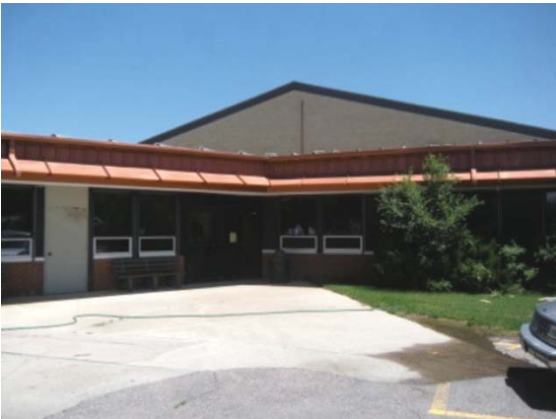
System: G4030 - Site Communication and Security

Analysis: The system is missing.

Location: Site
Material: Site Communications and Security
Distress: Missing
Category: Compliance
Priority: 3 - Necessary- 2-5 Yrs
Notes: The front entrance does not have bollards to protect against the forced entry.
Correction: Add security barrier/ bollards at front entry.
Qty: 75-L.F.
Condition Budget: \$6,093

Recommendation: The system should be installed.

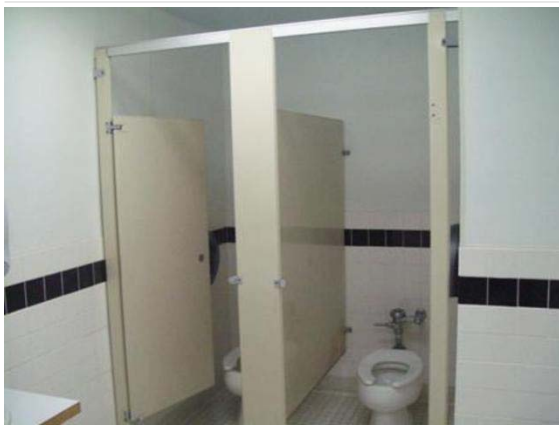
System: C1030 - Fittings

Analysis: The system age is either beyond expected life or does not meet its intended performance under the Guidelines. The system may be in service and functioning but it is recommended to be replaced due to probable increased condition budget needs, the potential failure of its components, or in order to meet the performance Guidelines for this system. The system was installed in 1978. It has a 20-year service life which expired in 1998.

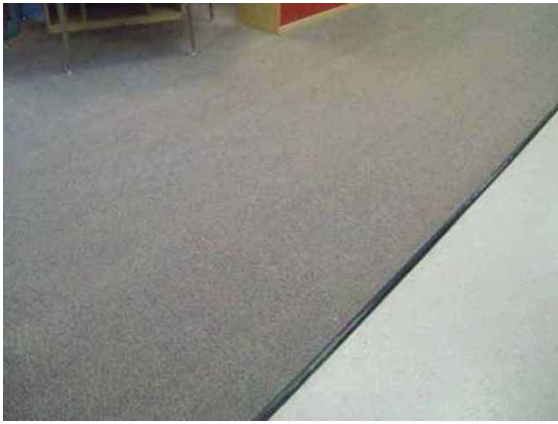
System: C3020 - Floor Finishes

Analysis: The system age is either beyond expected life or does not meet its intended performance under the Guidelines. The system may be in service and functioning but it is recommended to be replaced due to probable increased condition budget needs, the potential failure of its components, or in order to meet the performance Guidelines for this system. The system was installed in 1978. It has a 20-year service life which expired in 1998.

Condition Budget: \$1,580,319

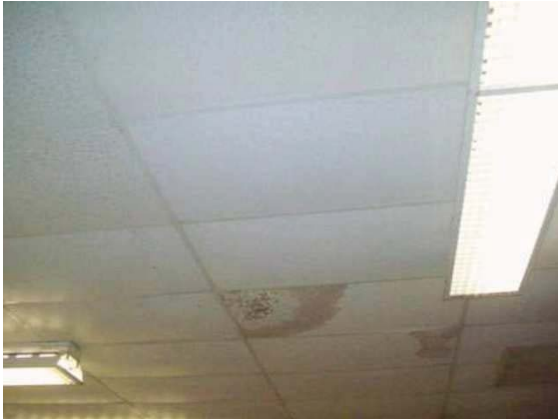
System: C3030 - Ceiling Finishes

Analysis: The system age is either beyond expected life or does not meet its intended performance under the Guidelines. The system may be in service and functioning but it is recommended to be replaced due to probable increased condition budget needs, the potential failure of its components, or in order to meet the performance Guidelines for this system. The system was installed in 1978. It has a 20-year service life which expired in 1998.

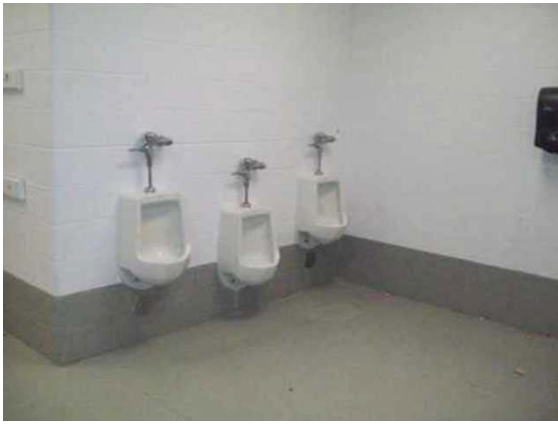
System: D2010 - Plumbing Fixtures

Analysis: The system age is either beyond expected life or does not meet its intended performance under the Guidelines. The system may be in service and functioning but it is recommended to be replaced due to probable increased condition budget needs, the potential failure of its components, or in order to meet the performance Guidelines for this system. The system was installed in 1978. It has a 30-year service life which expired in 2008.

Condition Budget: \$1,287,312

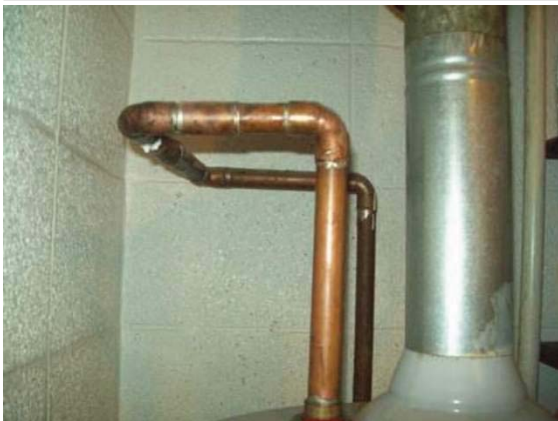
System: D2020 - Domestic Water Distribution

Analysis: The system age is either beyond expected life or does not meet its intended performance under the Guidelines. The system may be in service and functioning but it is recommended to be replaced due to probable increased condition budget needs, the potential failure of its components, or in order to meet the performance Guidelines for this system. The system was installed in 1978. It has a 30-year service life which expired in 2008.

Condition Budget: \$98,120

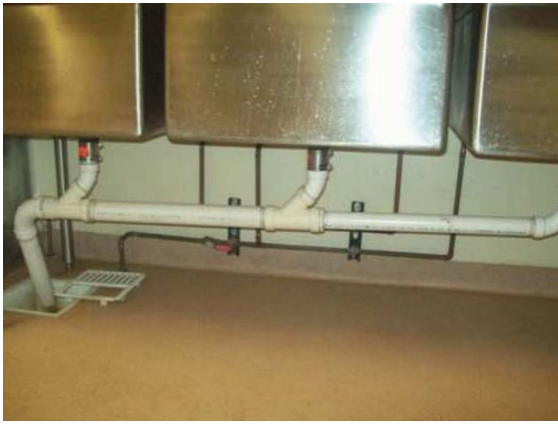
System: D2030 - Sanitary Waste
Analysis: The system age is either beyond expected life or does not meet its intended performance under the Guidelines. The system may be in service and functioning but it is recommended to be replaced due to probable increased condition budget needs, the potential failure of its components, or in order to meet the performance Guidelines for this system. The system was installed in 1978. It has a 30-year service life which expired in 2008.

Location: Main
Distress: Beyond Expected Life
Category: Deferred Maintenance
Priority: 3 - Necessary- 2-5 Yrs
Correction: Renew System
Qty: 1-Ea.
Condition Budget: \$246,786

Recommendation: The system should be replaced.

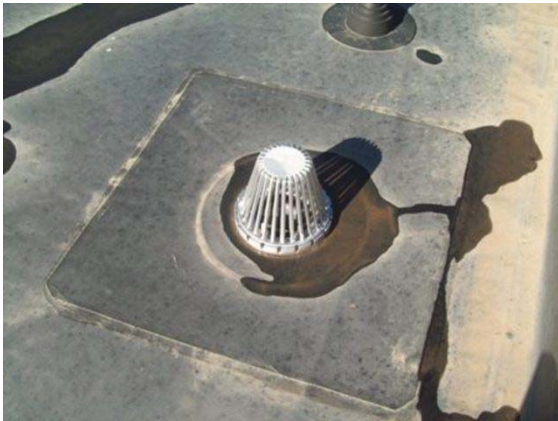
System: D2040 - Rain Water Drainage
Analysis: The system age is either beyond expected life or does not meet its intended performance under the Guidelines. The system may be in service and functioning but it is recommended to be replaced due to probable increased condition budget needs, the potential failure of its components, or in order to meet the performance Guidelines for this system. The system was installed in 1978. It has a 30-year service life which expired in 2008.

Recommendation: The system should be replaced.

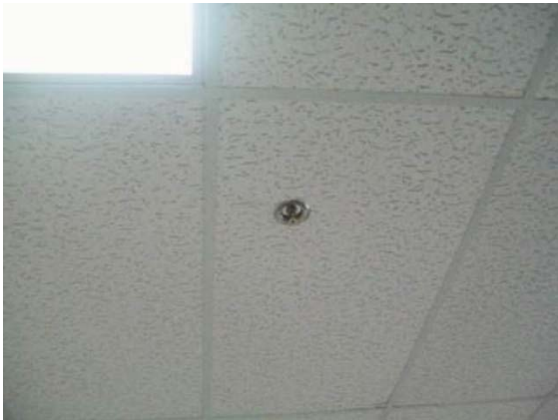
System: D4010 - Sprinklers

Analysis: The system age is either beyond expected life or does not meet its intended performance under the Guidelines. The system may be in service and functioning but it is recommended to be replaced due to probable increased condition budget needs, the potential failure of its components, or in order to meet the performance Guidelines for this system. The system was installed in 1978. It has a 30-year service life which expired in 2008.

Location: Main
Distress: Beyond Expected Life
Category: Deferred Maintenance
Priority: 3 - Necessary- 2-5 Yrs
Correction: Renew System
Qty: 1-Ea.
Condition Budget: \$83,253

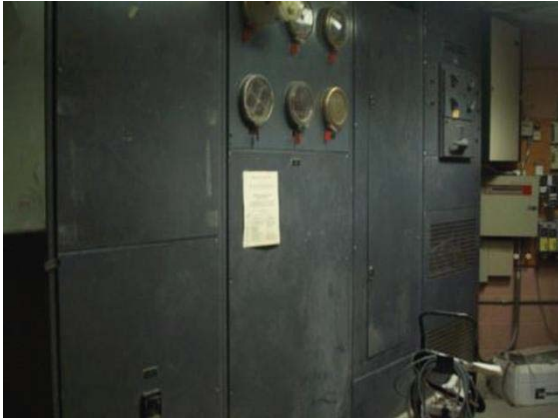
System: D5010 - Electrical Service/Distribution

Analysis: The system age is either beyond expected life or does not meet its intended performance under the Guidelines. The system may be in service and functioning but it is recommended to be replaced due to probable increased condition budget needs, the potential failure of its components, or in order to meet the performance Guidelines for this system. The system was installed in 1978. It has a 30-year service life which expired in 2008.

Location: Main
Distress: Beyond Expected Life
Category: Deferred Maintenance
Priority: 3 - Necessary- 2-5 Yrs
Correction: Renew System
Qty: 1-Ea.
Condition Budget: \$536,684

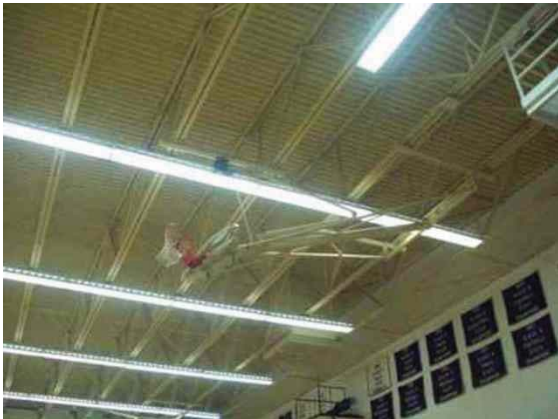
System: D5020 - Lighting and Branch Wiring

Analysis: The system age is either beyond expected life or does not meet its intended performance under the Guidelines. The system may be in service and functioning but it is recommended to be replaced due to probable increased condition budget needs, the potential failure of its components, or in order to meet the performance Guidelines for this system. The system was installed in 1978. It has a 30-year service life which expired in 2008.

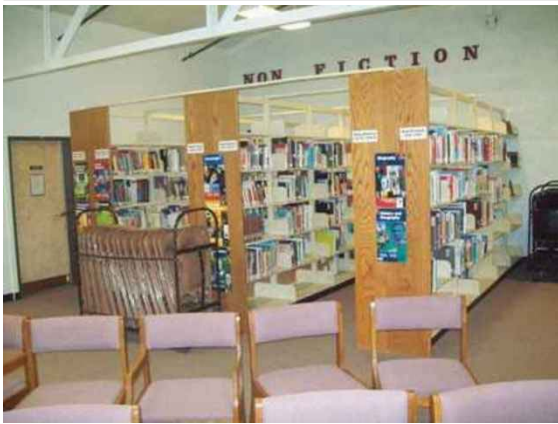
System: E1020 - Institutional Equipment

Analysis: The system age is either beyond expected life or does not meet its intended performance under the Guidelines. The system may be in service and functioning but it is recommended to be replaced due to probable increased condition budget needs, the potential failure of its components, or in order to meet the performance Guidelines for this system. The system was installed in 1978. It has a 20-year service life which expired in 1998.

Location: Main
Distress: Beyond Expected Life
Category: Deferred Maintenance
Priority: 3 - Necessary- 2-5 Yrs
Correction: Renew System
Qty: 1-Ea.
Condition Budget: \$118,933

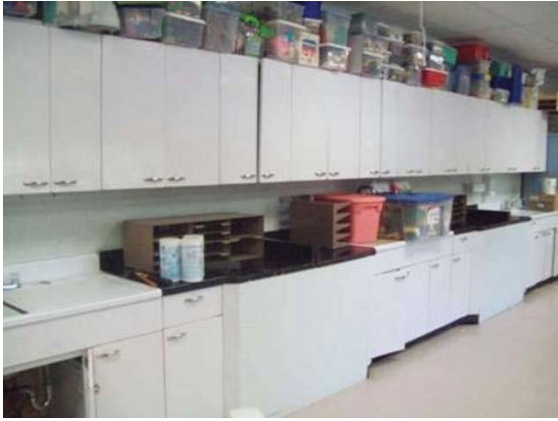
System: E2010 - Fixed Furnishings

Analysis: The system age is either beyond expected life or does not meet its intended performance under the Guidelines. The system may be in service and functioning but it is recommended to be replaced due to probable increased condition budget needs, the potential failure of its components, or in order to meet the performance Guidelines for this system. The system was installed in 1978. It has a 20-year service life which expired in 1998.
